2393-3 Wolf Run, Fayetteville, Arkansas 72704

Inspection Date:

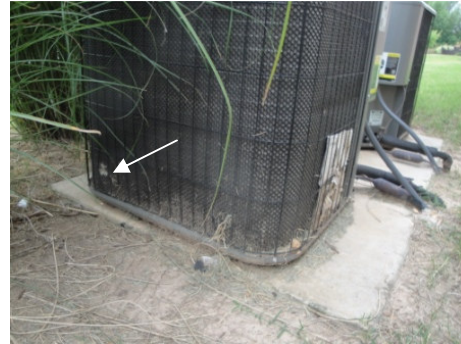
Figure 2: Grass in the condenser coils and an area of damaged coils.

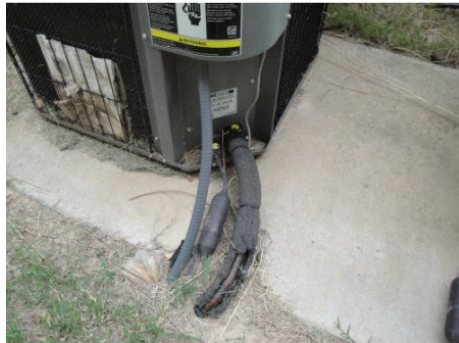
Figure 3: Insulation of refrigerant lines was in need of replacement.

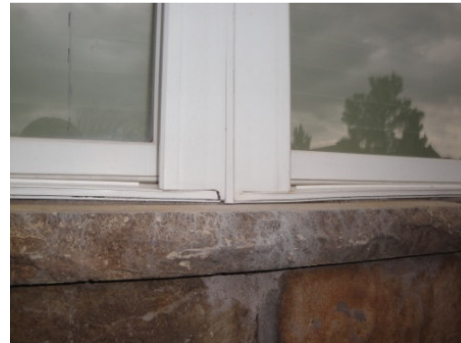
Figure 4: Window sash took form of unlevel sill.

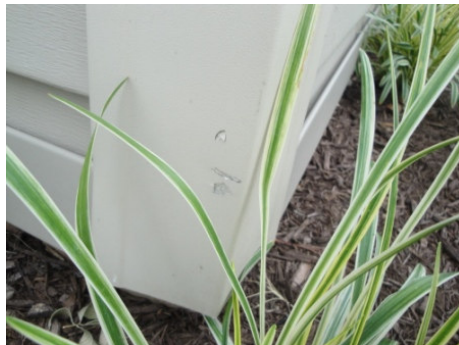
Figure 5: Cracked vinyl trim.

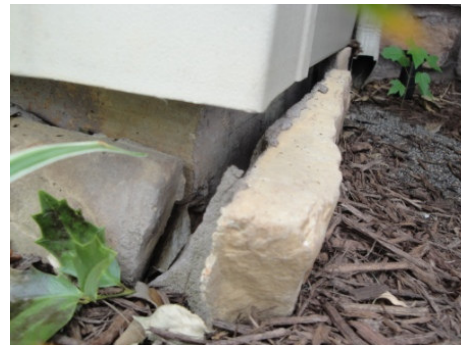
Figure 6: Siding rock loose from side of slab.

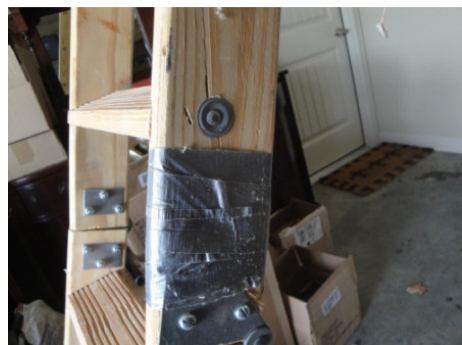
Figure 7: Duct taped attic ladder.

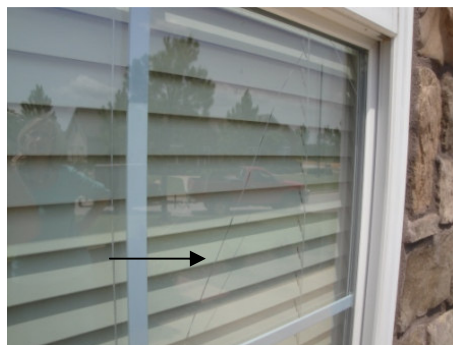
Figure 8: Cracked window.

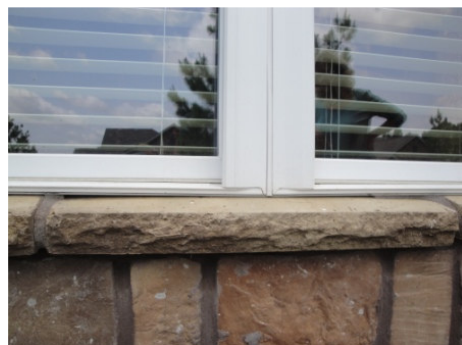
Figure 9: Another unlevel sill where the window sash bottom was not sealed properly.

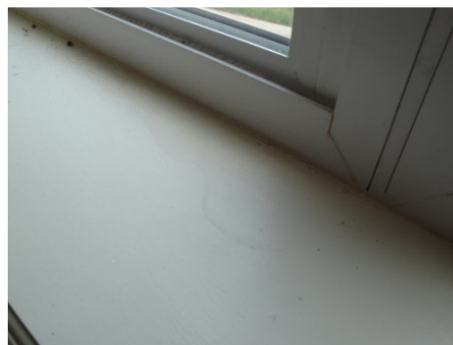
Figure 10: Interior of a north window (inside of window in figure 9) had a moisture stain in the middle of the interior window sill.

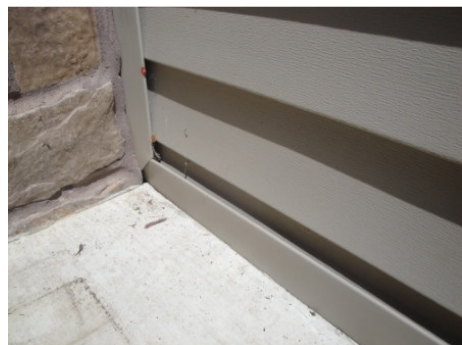
Figure 11: Hole at floor corner of the front entry and wall/floor connection could possibly be responsible for allowing moisture into the NE room.

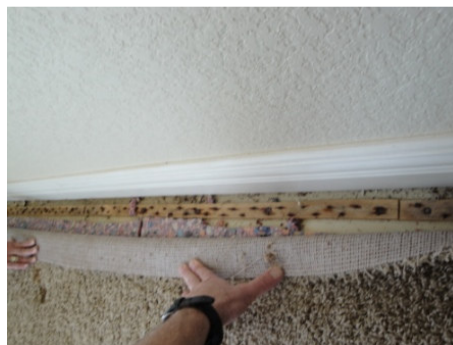
Figure 12: Evidence of moisture on carpet tack board (rusting nails) and peeling paint that was on the slab.

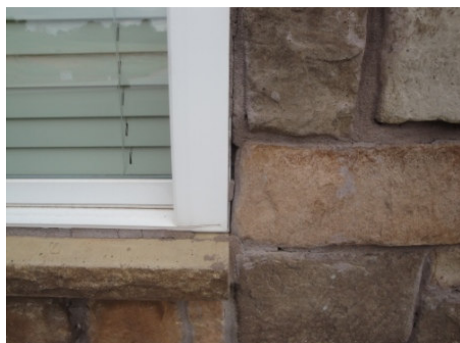
Figure 13: Window mortar missing from bottom right of window may be responsible for allowing moisture to enter the east bedroom.

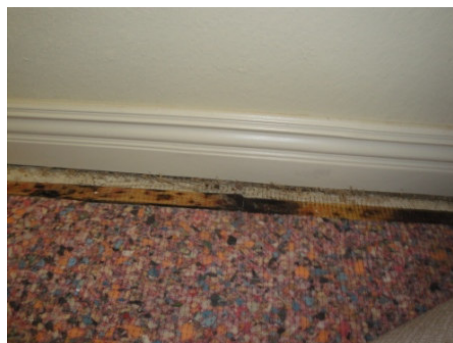
Figure 14: Area of floor beneath the missing mortar of the window from figure 13 was showing moisture stains and rusting nails.

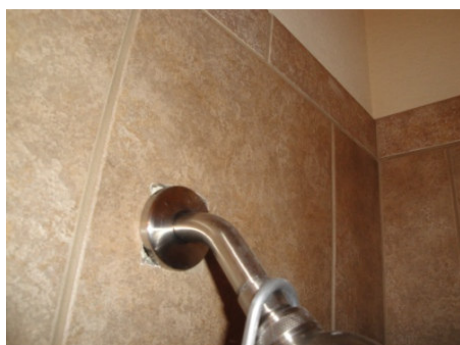
Figure 15: Cut tile of shower head piping in the master bathroom was in need of sealing.

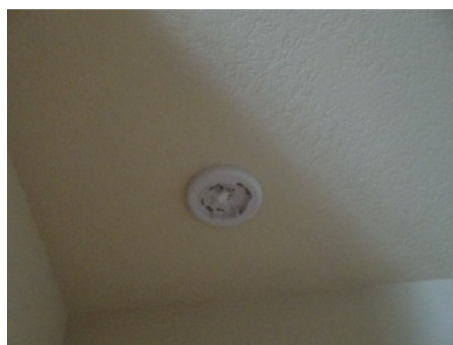
Figure 16: Missing smoke detector in master bedroom.

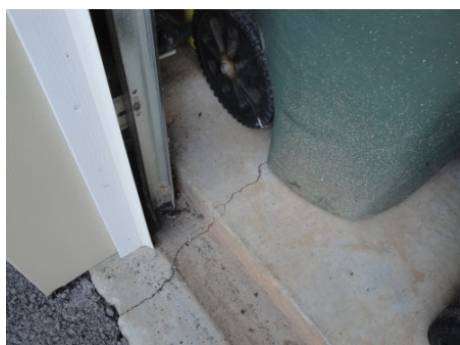
Figure 17: The beginning of a concrete floor crack in the garage could not be further evaluated due to current tenants' stored items.

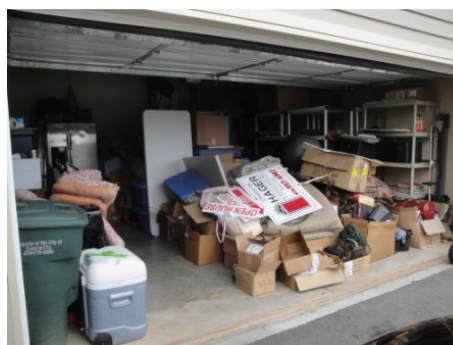
Figure 18: Garage full of stored items.

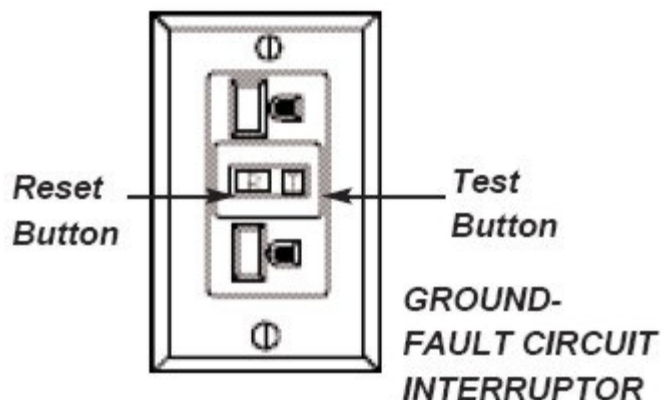
If you do have G.F.C.I.'s, it is recommended that you test (and reset) them monthly. When you push the test button, the reset button should pop out, shutting off the circuit. If it doesn't, the breaker is not working properly. If you don't test them once a month, the breakers have a tendency to stick and may not protect you when needed.
