785 Asboth, Pea Ridge, Arkansas 72751

Report Number:

052011A

REPORT OVERVIEW

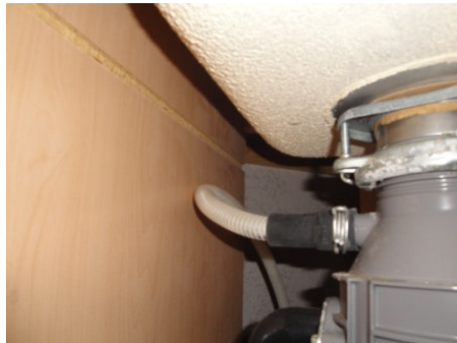
Figure 1: Bring the dishwashing machine drain line up to where it is higher than the bottom of the sink basin.

Drain lines had no visible leaks or signs of backup at the time of inspection. There were no visible active piping leaks at the time of the inspection. Recommend looping the dishwasher drain line to where a portion of it is above the bottom of the sink, this will help prevent siphoning grey water back into the dishwasher. Countertops and cabinets had normal wear. No anti-tip bracket appeared to be installed behind the oven/range - potential safety hazard. The kitchen sink did not have a very good water flow when it was running the same time as the jetted tub faucet was running. A light in the ceiling kept turning itself on and off, recommend further review and correction as necessary. The dishwashing machine dripped about a teaspoon of water from the from right corner during operation, repair as necessary.

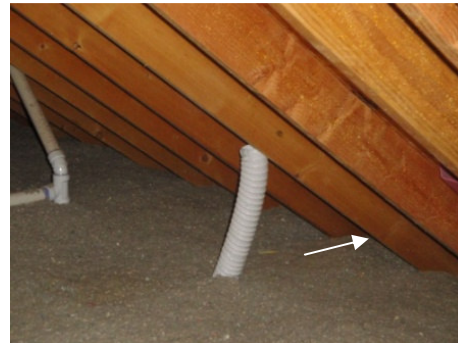
Figure 2: Bathroom exhaust fan extension could be taken off its nail and laid down toward the soffit venting of the eave.

Rafters appeared to be in overall adequate condition. Roof sheathing, examined from the attic, showed no major defects or moisture damage. Insulation was average, but could be upgraded. Ventilation was normal. Recommend extending bathroom fan extensions toward the exterior. Vapor barrier not visible.

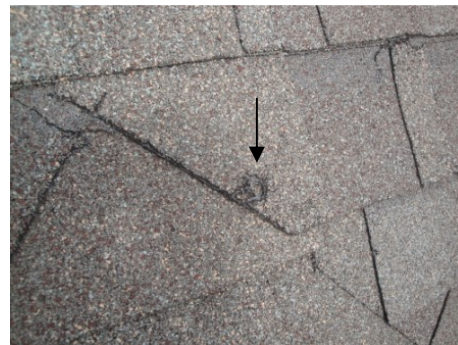
Figure 4: Several small holes were noted in the shingles.

Roof covering appeared a bit older than 5 years but was in overall adequate condition with a few areas that were in need of light maintenance work. Rubber boots around plumbing vents had started to tear, recommend replacing rubber boots as necessary.

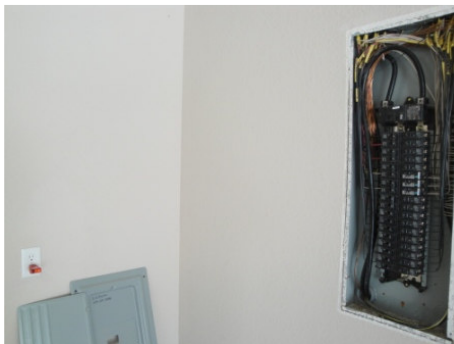
Figure 5: The electrical outlet in the NW corner of the garage did not appear to be GFCI protected.

The pressure reverse function did not operate properly at the time of the inspection – potential safety hazard. The pressure reverse function should sense that the door rested on something other than the ground and reverse direction. The NW electrical outlet in the garage was not GFCI protected – potential safety hazard. This was probably intended for a refrigerator/freezer plug-in as a refrigerator/freezer should not have GFCI, if it kicked off you could lose all the contents of the refrigerator/freezer. Recommend plugging in a refrigerator and blocking the access to the outlet or have a licensed electrician add GFCI protection to it. The Craftmaster brand garage door opener operated, the Accessmaster brand did not operate. Garage door was slightly bent but still operated. The south ceiling light fixture did not appear to operate at the time of the inspection.

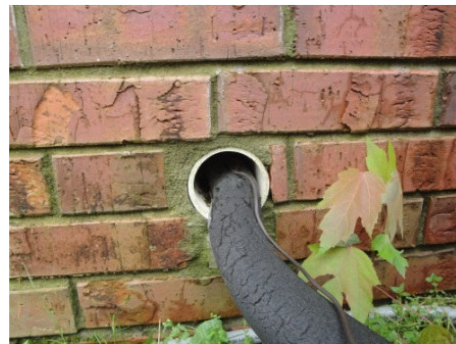
Figure 6: Utility entrance that could be filled with expanding foam or similar.

Condenser coils may be dirty, have reviewed and cleaned as necessary. Recommend filling any open areas where utilities enter the house with expanding foam or similar to help prevent 'critters' from entering, see picture summary for pictorial description.

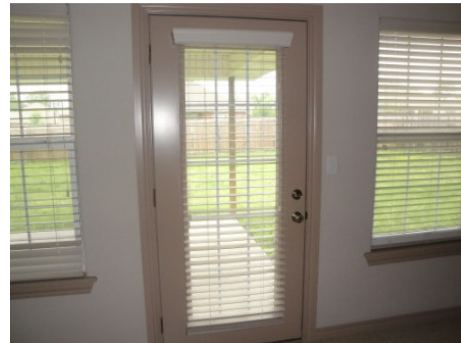
The windows within 2 feet of the back door did not appear to be safety tempered glass – potential safety hazard.

Figure 8: Windows within 2 feet from the back exterior door did not appear to be safety tempered glass.

The pressure reverse function of the garage door did not operate properly at the time of the inspection.
No anti-tip bracket appeared to be installed behind the oven/range.
The windows within 2 feet of the back door and the window above the master tub could not be verified to be safety tempered glass.
The NW electrical outlet in the garage was not GFCI protected.
Gas appeared to be slightly leaking from the top fire port of the furnace which could be considered a potential safety hazard.

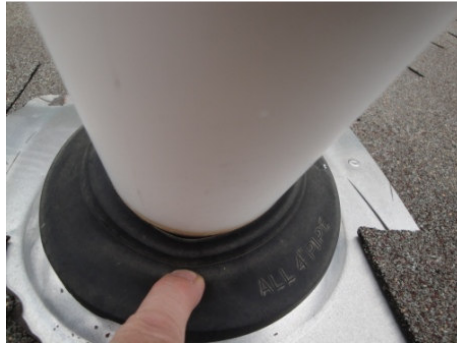
Figure 9: Rubber boot of a north plumbing vent could have pushed down during heavy rains and allowed water to travel downwards.

The moisture stain on the ceiling appeared to come in from the plumbing vent above it. The plumbing vent's flashing and rubber boot appeared to be in decent condition yet the heavy rains may have pushed in the rubber boot and allowed rain to run down the plumbing vent and end up on the ceiling of the bedroom below it. Recommend monitoring and contacting a roofing contractor for further review and repair if the moisture penetration continues.

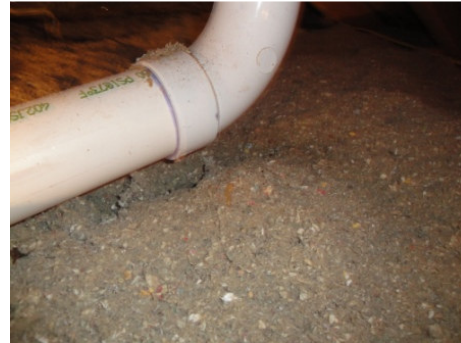
Figure 10: Moisture beneath the plumbing vent viewed from the attic.

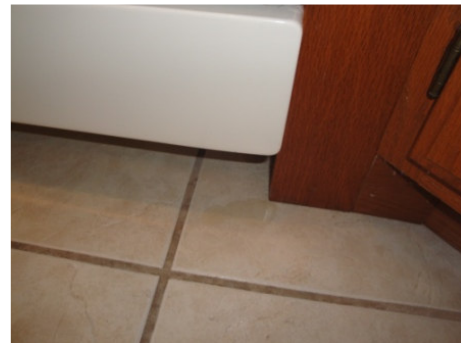
Figure 12: About a teaspoon of water under the dishwashing machine.

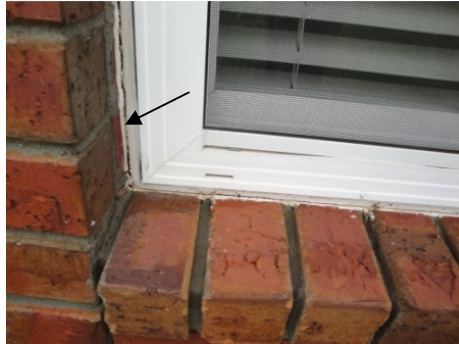
Figure 13: Example of where to caulk exterior of windows.

Gutters were in overall adequate condition. Maintain downspout discharge away from the house. Recommend add gutters to the north and south sides as necessary. Siding and trim appeared to be all intact and in overall satisfactory condition. Normal caulking maintenance would be helpful, recommend caulking the interior and exterior of windows to help prevent moisture penetration.

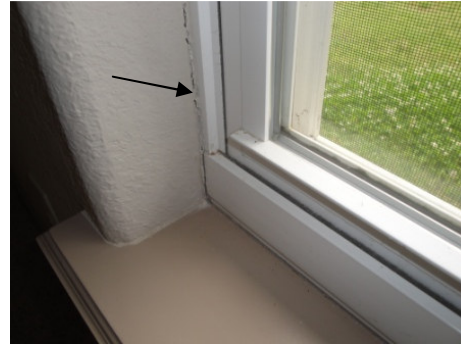
Figure 14: Example of where to caulk interior of windows.
